## ZWELITSHA PEDESTRIAN BRIDGE, EAST LONDON

By John Anderson, Technical Director,  
Vela VKE Consulting Engineers  
incorporating Munyai Malaka Engineers

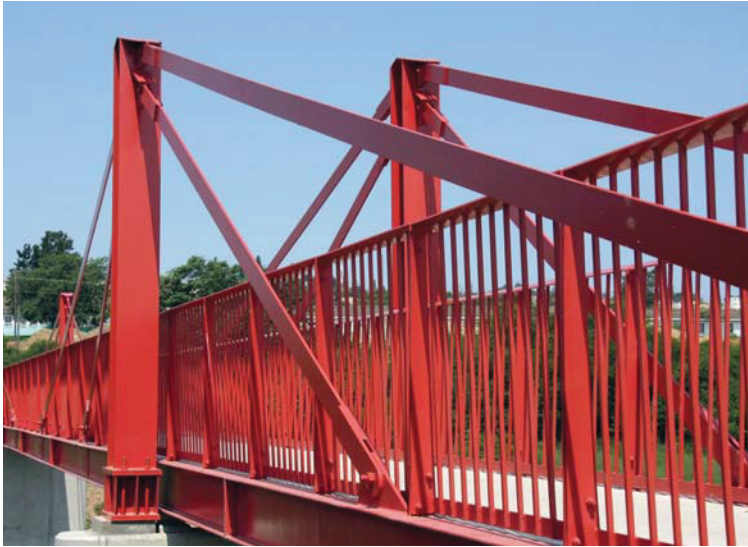
*The bridge provides a safe crossing point for some 500 pedestrians who cross the Buffalo River each day. It provides access for the surrounding communities to schools, clinics and police services. It will also prevent the tragic drownings that have happened in the past.*

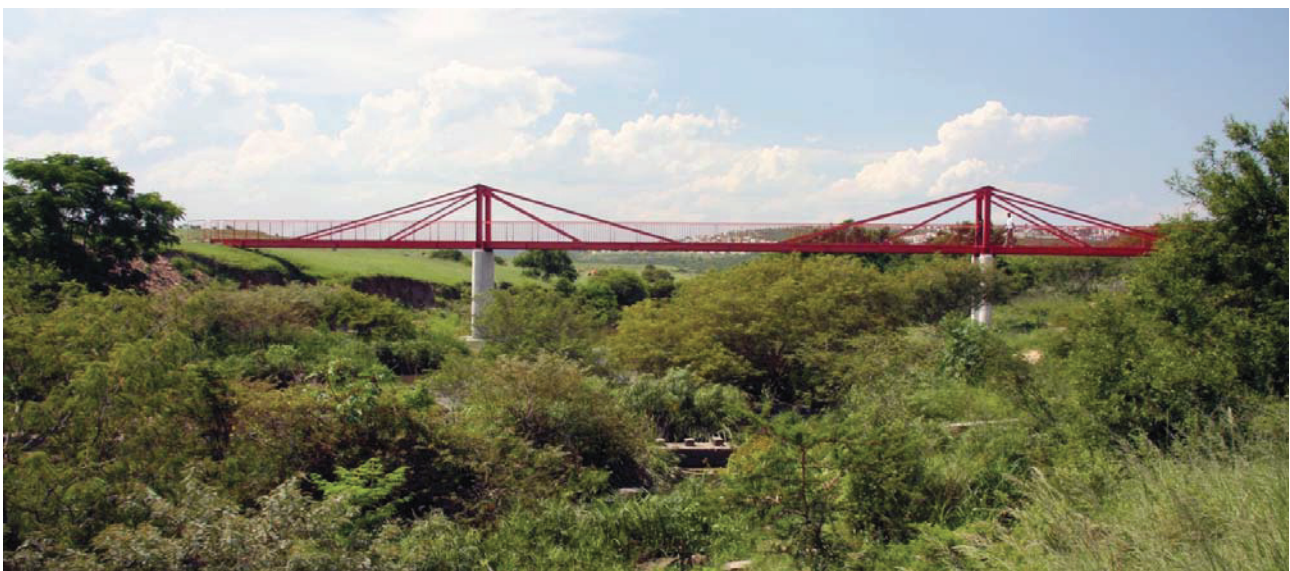
U-frame structural steel pratt trusses are often used in South Africa for pedestrian bridges in rural areas. In this case the client accepted a more attractive alternative, a three span cable stayed structure with a main span of 27m and back-spans of 17m.

The bridge design responds to the natural surrounds of the Buffalo River. Low towers with a limited amount of stays give the bridge an appropriate scale.

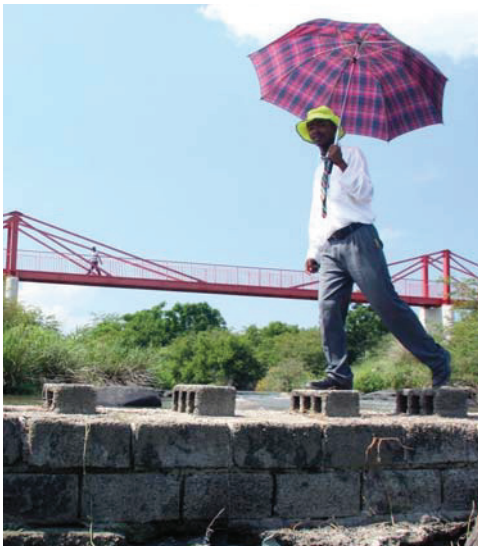
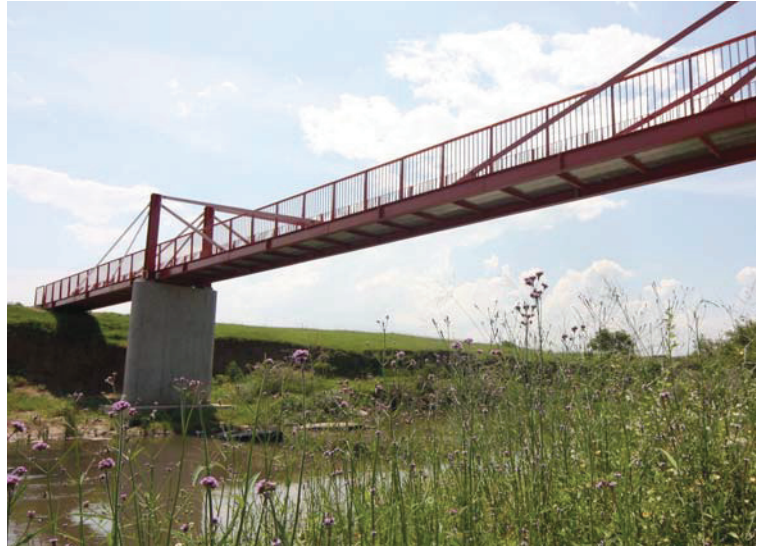
A key element in the detailing of the bridge was to restrict the length of the individual elements. Thus the sections were easy to handle on-site and could be galvanized. This allowed the specification of a 'duplex' paint system that will ensure the bridge requires minimal future maintenance. An important benefit of bolting the bridge together was that no on-site welding was required. This ensured that the galvanising was not damaged during the erection process.

All the bridge elements are commonly used standard sections such as H-section towers support stays that are constructed from standard steel flats. These stays connect with a simple spade and fork connection detail to the I-beams (356 x 171 x 45) used in the deck section. A simple handrail, fabricated into independent panels was bolted into place with sufficient tolerance to easily align it.

The steel towers are integral with the concrete piers. Their stiffness is relied upon to limit the deflection in the deck due to asymmetric pedestrian loading. The resulting high moments in the towers are transferred to the concrete pier bases that are dowelled into the river's rock bed.

The deck section floats independently of the towers and its longitudinal restraint is provided by the stays. This was the only alternative that maintained adequate tension forces in the stays during the thermal expansion and contraction of the deck. The resulting structural system is relatively complex. Parametric studies showed that as the stiffness of the beam increased so did the non-linear behaviour of the structure.
